# Check Out

123 Sample Street  
Sample City  
Sampleshire, AB1 2CD

19 July 2026

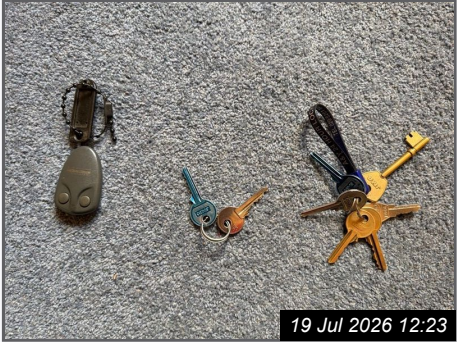
| Ref | Name | Description | Additional Comments |
|---|---|---|---|
| 4.1 | Keys at Check out | <div>1x Set:</div> <div>1x Yale for main entry top lock</div> <div>1x Chubb for main entry bottom lock</div> <div>2x Yale for Living Room entry gate</div> <div>2x Yale for Living Room entry</div> <div>1x Fob for parking</div> <div>1x Letterbox</div> | |

| Ref | Name | Description | Additional Comments |
|---|---|---|---|
| 4.2 | Action | Collected from tenant, returned to agent | |

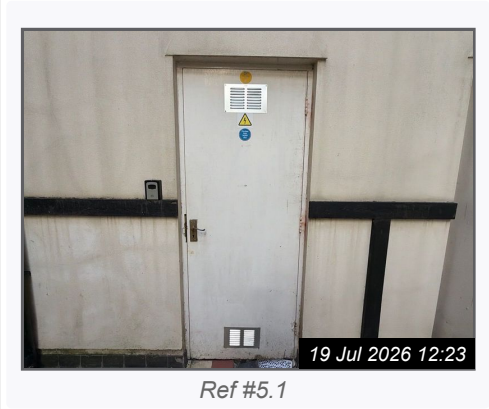
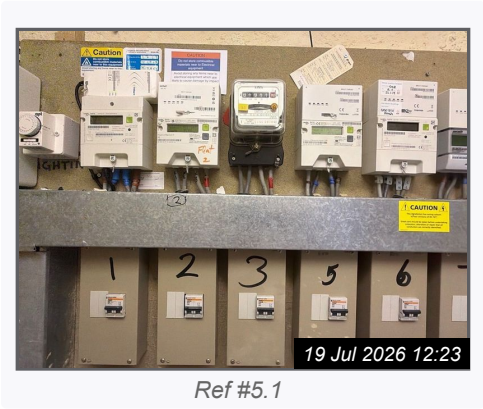
| Ref | Name | Description | Reading | Additional Comments |
|---|---|---|---|---|
| 5.1 | Electric Meter | Location: Communal Hallway Cupboard. Key in safe box next to door, code required, supplied by tenant<br>Serial No: L75E09706 | 81911 kWh | |

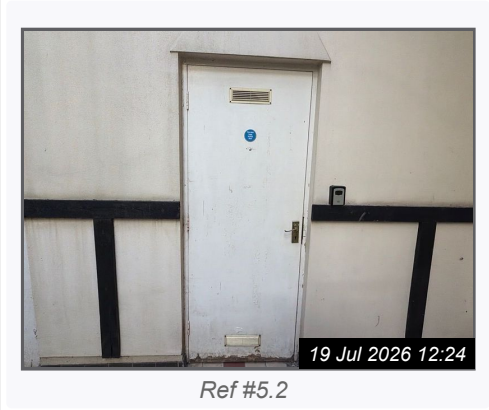
| 5.2 | Gas Meter | Location: Communal Hallway Cupboard. Key in safe box next to door, code required, supplied by tenant<br>Serial No: 6263984SC | 9198 ft3 | |

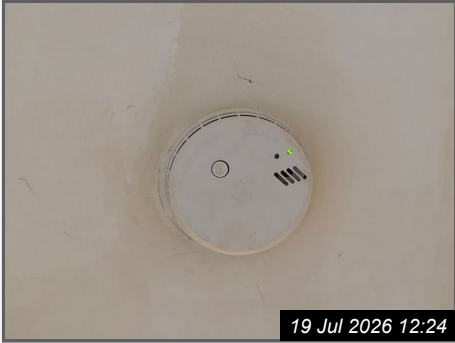
| Ref | Name | Location Room & Floor | Test Result | Additional Comments |
|---|---|---|---|---|
| <div><p>Ref #6.1</p></div> | | | | |

| Ref | Name | Location Room & Floor | Test Result | Additional Comments |
|---|---|---|---|---|
| 6.1 | Smoke Alarm | 1x Hallway | Tested for power only<br>Audible sound noted<br>Exp. date not seen | |

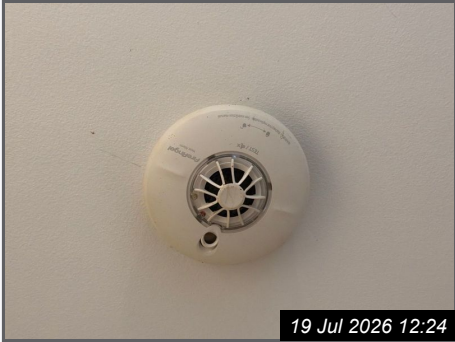
| Ref | Name | Location Room & Floor | Test Result | Additional Comments |
|---|---|---|---|---|
| <div><p>Ref #6.2</p></div> | | | | |

| Ref | Name | Location Room & Floor | Test Result | Additional Comments |
|---|---|---|---|---|
| 6.2 | Heat Alarm | 1x Kitchen | Tested for power only<br>Audible sound noted<br>Exp. date not seen | |

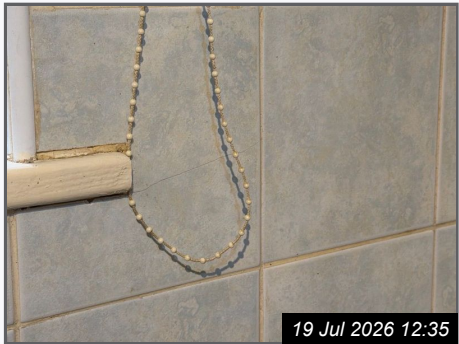
Ref #8.5

| 8.5 | Walls | White painted<br>Light blue ceramic tiles | Picture hook to right wall<br>Light crack to tile right of window<br>Some shading, spot stains, marks and rubs in places.<br>Some brown stains by extractor -<br>Fair wear and tear<br>Water damage right of window<br><div>Needs Maintenance - Tenant + Investigate</div> | |

| Needs Maintenance | | |
|---|---|---|
| <u>8.5</u> KITCHEN » Walls | Investigate | Water damage right of window |

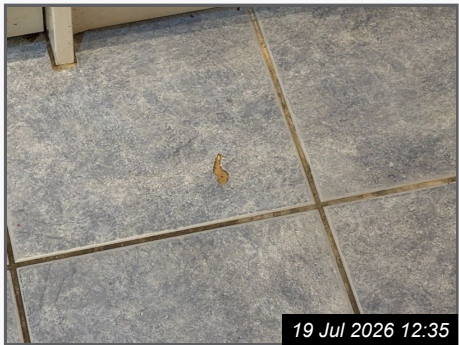
Ref #8.8

| 8.8 | Floor | Blue ceramic tiles<br>Brass carpet strip | 3cm chip forward of drawer unit -<br>Fair wear and tear | |

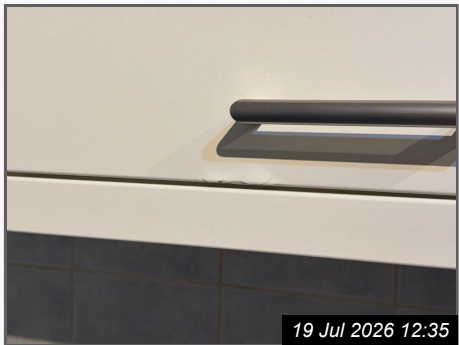
Ref #8.12

| 8.12 | Wall Units | Off-white laminate<br>Brushed steel handles | Minor chipping, cracking and bubbling - Fair wear and tear<br>Notable brown stains to unit by Boiler<br><div>Needs Cleaning - Tenant</div> | |

| Needs Cleaning | | |
|---|---|---|
| <u>8.12</u> KITCHEN » Wall Units | Tenant | Notable brown stains to unit by Boiler |

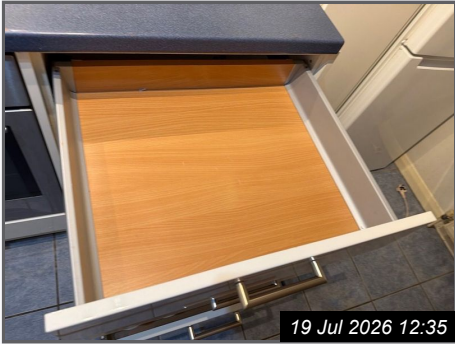
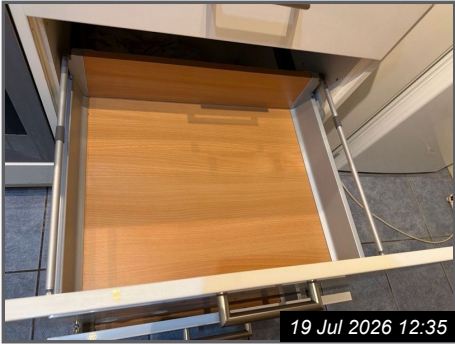
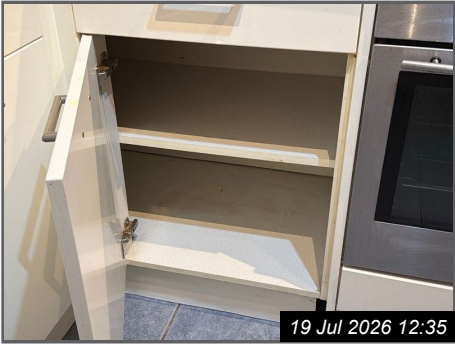
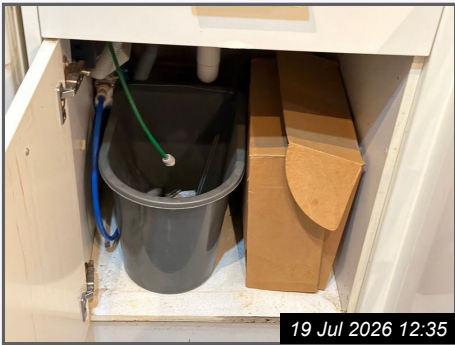
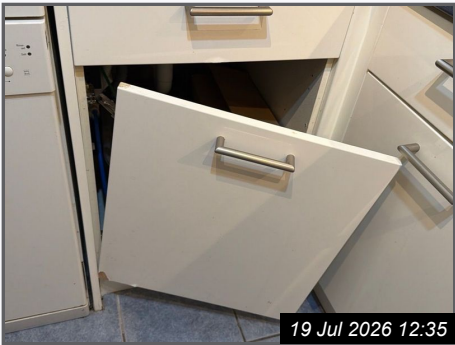
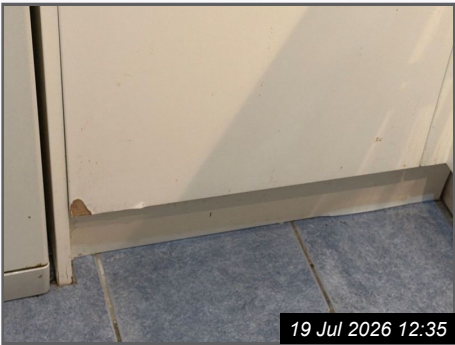
| 8.13 | Base Units | White laminate<br>Brushed steel handles | Minor wear, chipping - Fair wear and tear<br>Door by sink loose on hinge<br>Needs Maintenance - Investigate | |

| Needs Maintenance | | |
|---|---|---|
| <u>8.13</u> KITCHEN » Base Units | Investigate | Door by sink loose on hinge |

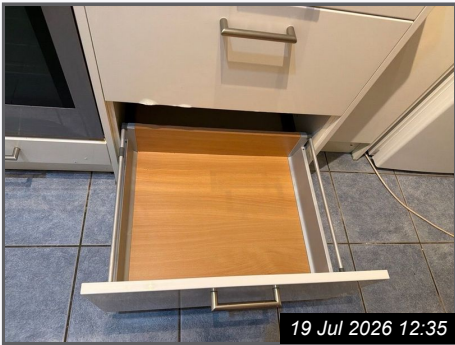
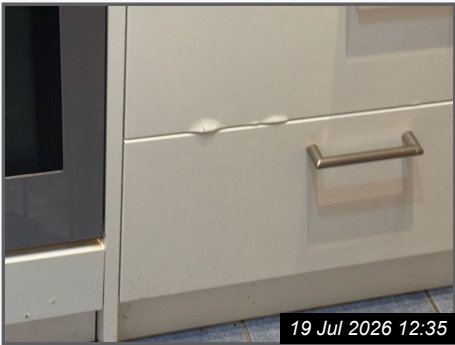
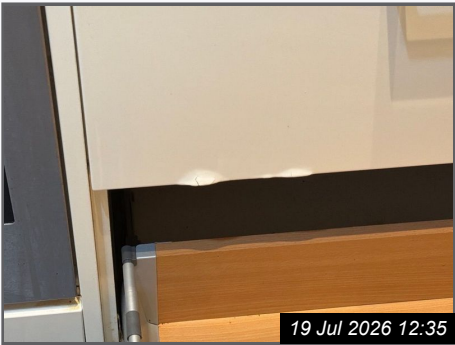
| 8.14 | Drawer Units | White laminate<br>Brushed steel handles | Minor cracking and bubbling - Fair wear and tear |

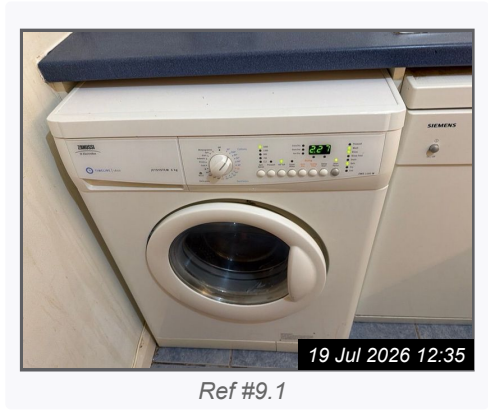
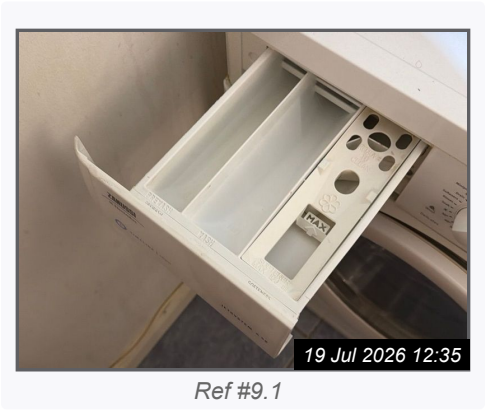
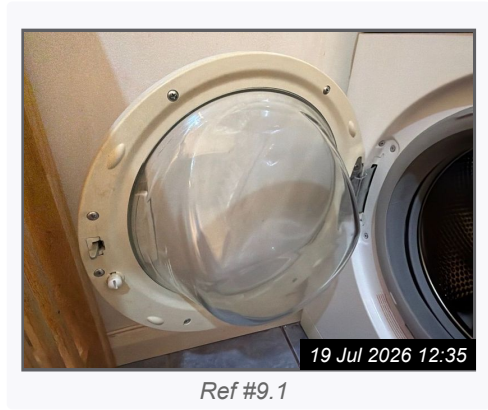
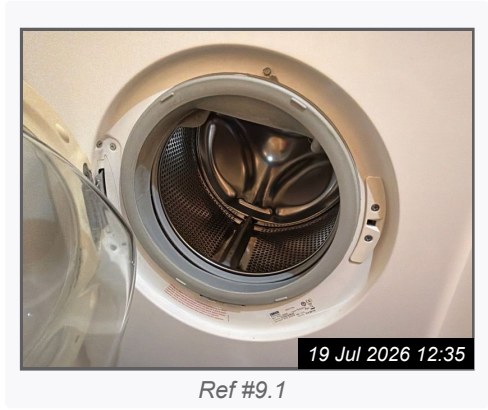
Ref #9.1

| Ref | Name | Description | Condition | Additional Comments |
|---|---|---|---|---|
| 9.1 | Washing Machine | White Zanussi | Power tested<br>Clean | |

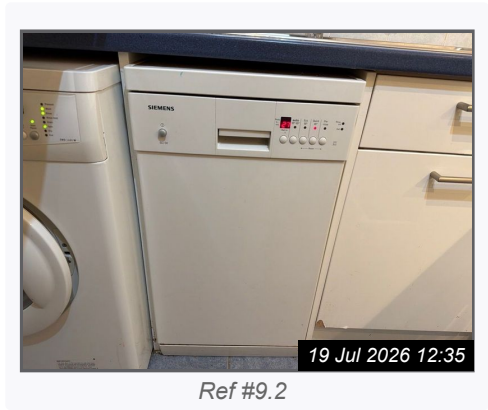
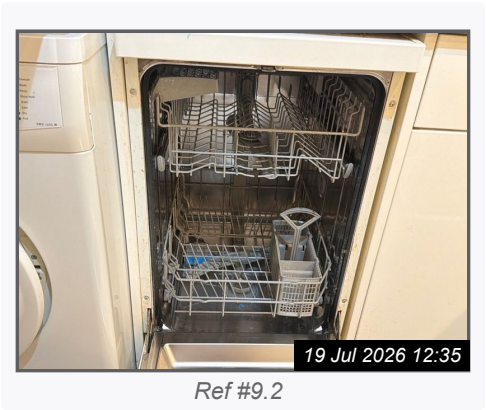
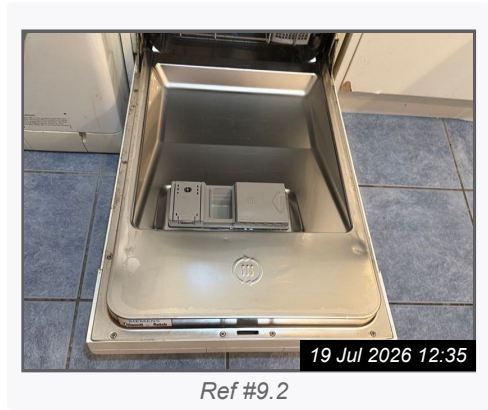
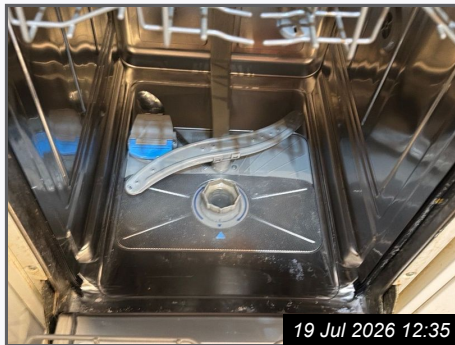
Ref #9.2

| 9.2 | Dishwasher | White Siemens | Power tested<br>Notable water residue seen to base of unit<br>Not fully cleaned<br>Needs Cleaning - Tenant | |

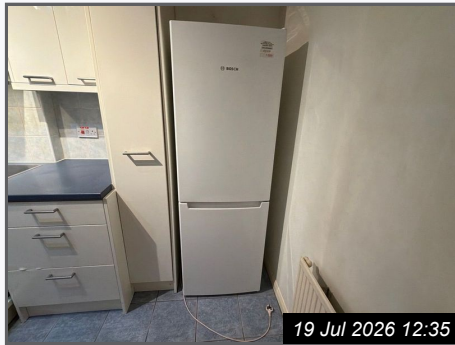
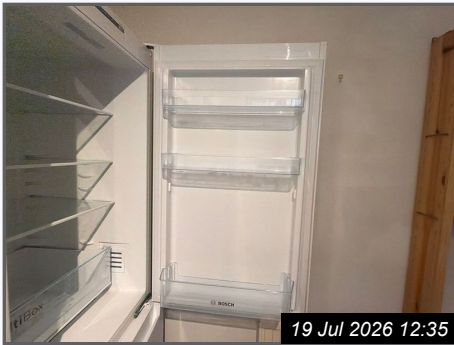
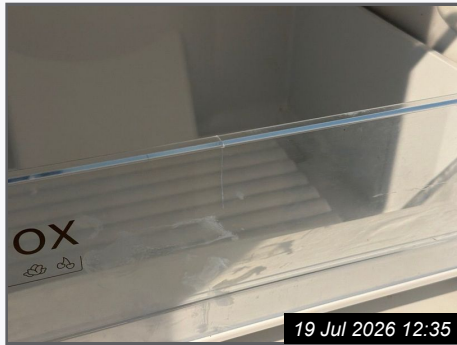
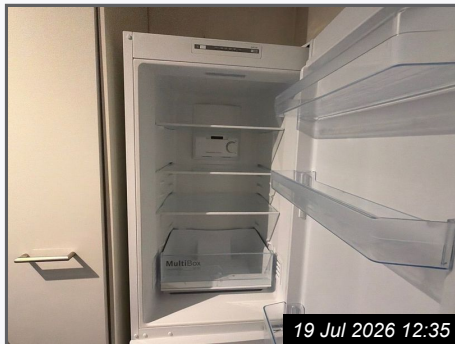
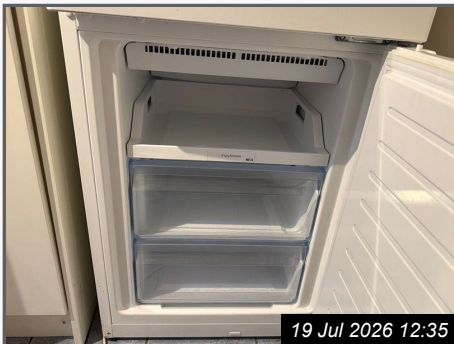
| 9.3 | Fridge / Freezer | White Bosch<br>3x Glass shelves<br>Salad crisper<br>3x Door compartments<br>White plastic pull out drawer<br>2x Further drawers tiles freezer | Not tested<br>Currently unplugged<br>1x Shelf appears to be missing<br>4cm crack to salad crisper front to centre - Fair wear and tear<br>Clean<br><div>Needs Replacing - Tenant</div> | |

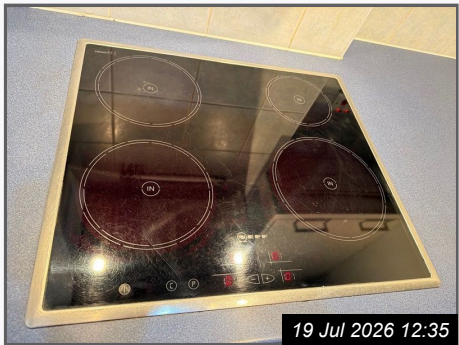
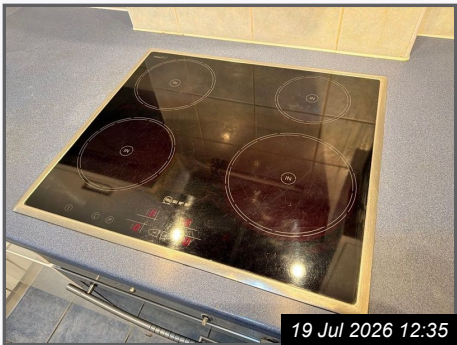
Ref #9.4

| 9.4 | Hob | Black glass Neff<br>4x Electric rings<br>Touch controls | Power tested<br>Minor usage scratches - Fair wear and tear<br>Clean | |

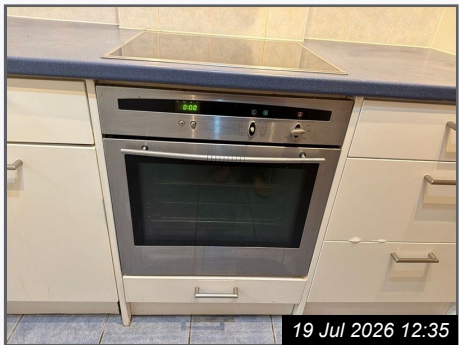
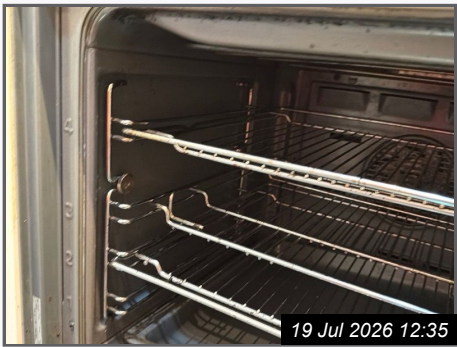
Ref #9.5

| 9.5 | Oven | Stainless steel and black glass<br>Brushed steel handle<br>2x Chrome racks<br>Grey metal baking tray with chrome rack | Power tested<br>Light not seen working<br>1x Control missing<br>Some minor stains, burnt on stains to interior<br>Otherwise clean<br>Needs Replacing - Tenant<br>Needs Cleaning - Tenant |

| Needs Cleaning | | |
|---|---|---|
| <u>9.5</u> KITCHEN APPLIANCES » Oven | Tenant | Some minor stains, burnt on stains to interior |

| Needs Replacing | | |
|---|---|---|
| <u>9.5</u> KITCHEN APPLIANCES » Oven | Tenant | Light not seen working<br>1x Control missing |

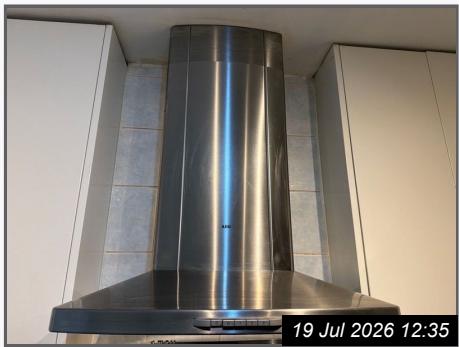
Ref #9.6

| 9.6 | Extractor Hood | Stainless steel AEG<br>2x Filters and 2x Lights<br>Controls | Power tested<br>Lights working<br>Lights coming off loose<br>Minor brown stains to filters<br><div>Needs Maintenance - Investigate</div> <div>Needs Cleaning - Tenant</div> | |

| Needs Maintenance | | |
|---|---|---|
| <u>9.6</u> KITCHEN APPLIANCES » Extractor Hood | Investigate | Lights coming off loose |

| Needs Cleaning | | |
|---|---|---|
| <u>9.6</u> KITCHEN APPLIANCES » Extractor Hood | Tenant | Minor brown stains to filters |

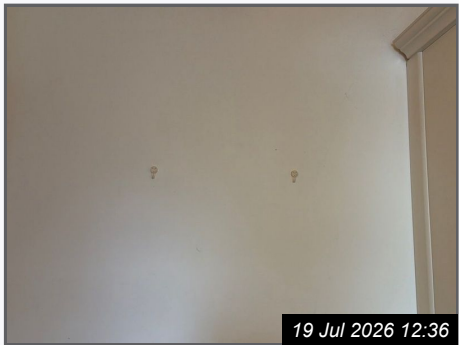
Ref #10.5

| Ref | Name | Description | Condition | Additional Comments |
|---|---|---|---|---|
| 10.5 | Walls | White painted | 6x Picture hooks<br>Shading, light chipping and faint usage - Fair wear and tear<br>Needs Maintenance - Tenant | |

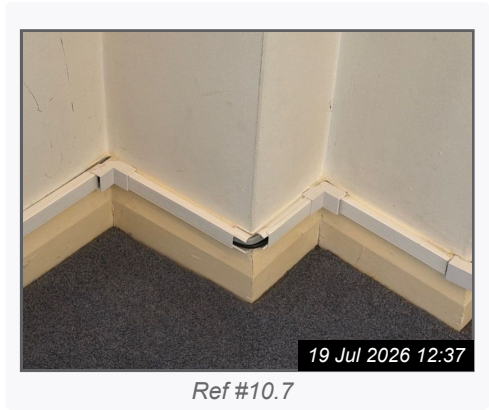
| 10.7 | Woodwork | White painted wooden skirting | Part of trunking not seen to corner<br>Needs Replacing - Investigate | |

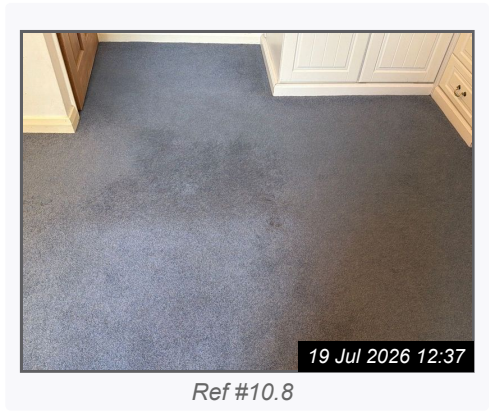
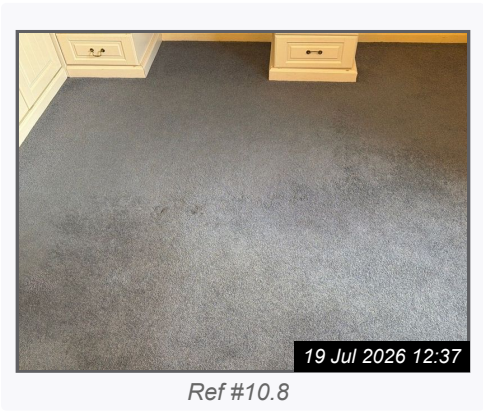
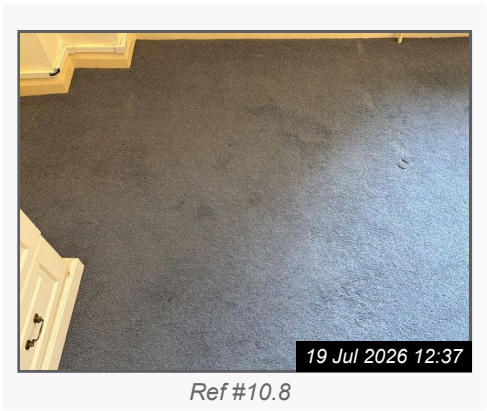
| 10.8 | Floor | Blue fitted carpet | Shaded with faint brown stain - Fair wear and tear | |

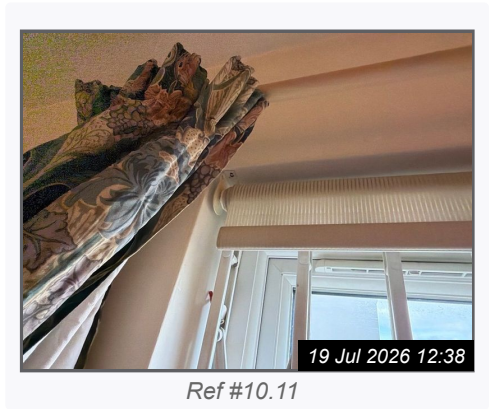
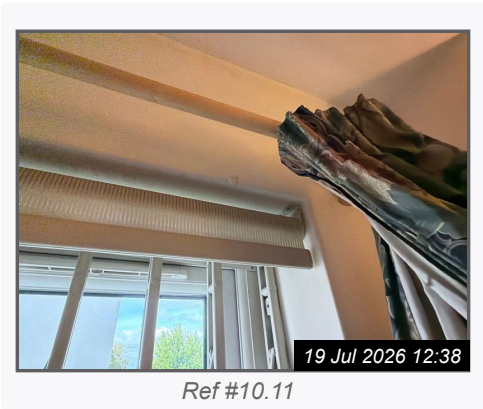
| 10.11 | Curtains and Blinds | White metal security grilles with lock<br>1x Key<br>Beige roller blind<br>Wooden curtain pole<br>2x Multicoloured dark patterned curtains | Cord to blind not seen<br>Needs Replacing - Tenant | |

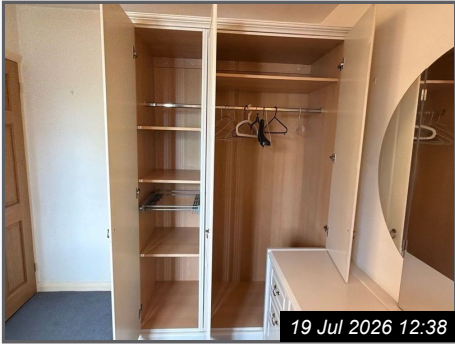
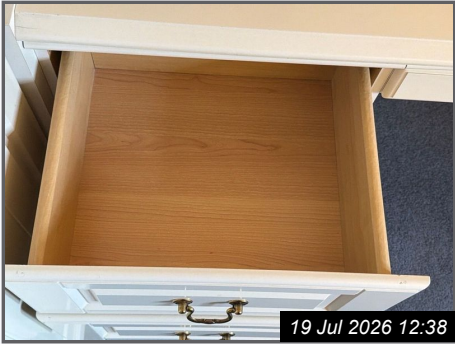
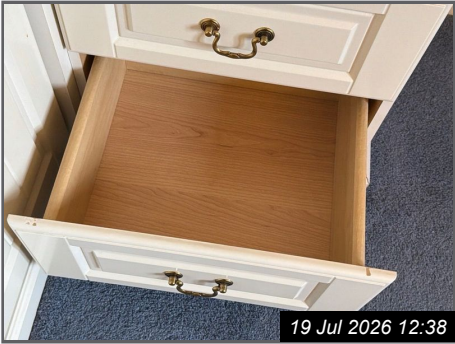
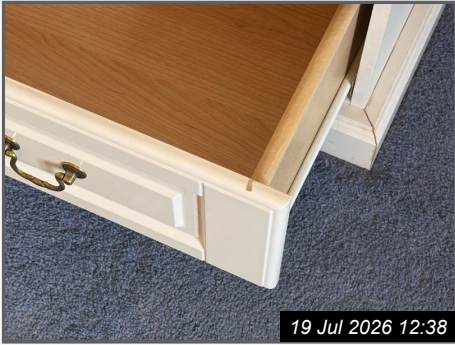
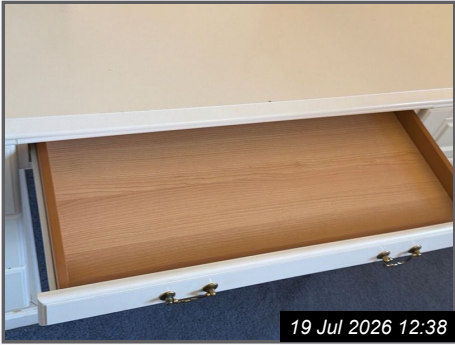
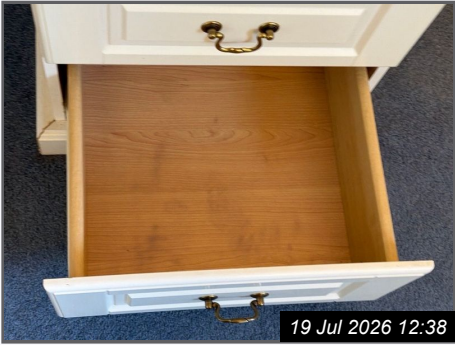
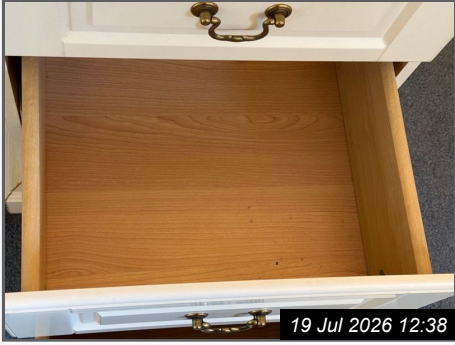
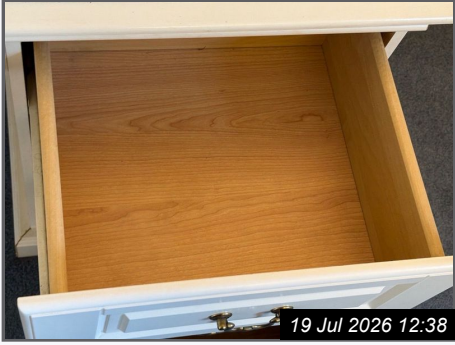
| 10.12 | Wardrobe | Off-white painted wooden with 3x doors<br>Brass pulls<br>2x Chrome rails<br>Shelves<br>Assorted hangers | Minor usage marks - Fair wear and tear | |

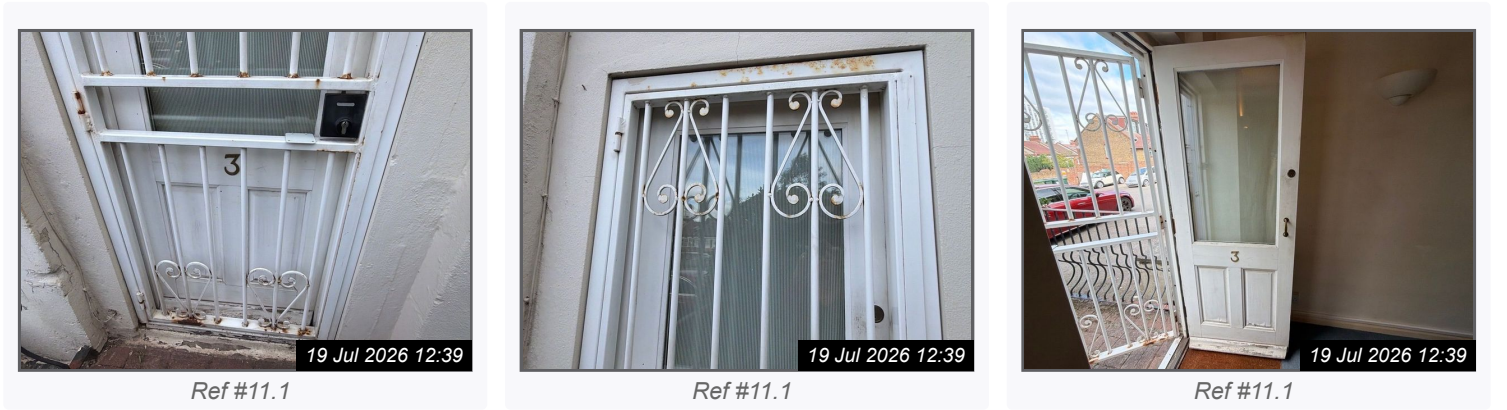
| Ref | Name | Description | Condition | Additional Comments |
|---|---|---|---|---|
| 11.1 | Door and Frame | White metal gate<br>White painted wooden with glass panel<br>White painted wooden frame | Notable rust to gate<br>Moderate chipping to door low level<br>- Fair wear and tear | |

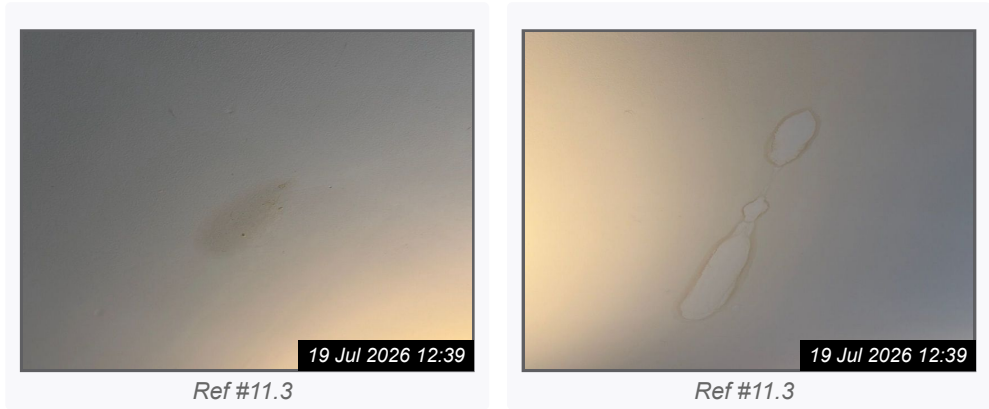
| 11.3 | Ceiling | White painted | Moderate to heavy water staining towards Inner hallway<br>Needs Maintenance - Investigate | |

| Needs Maintenance | | |
|---|---|---|
| <u>11.3</u> RECEPTION » Ceiling | Investigate | Moderate to heavy water staining towards Inner hallway |

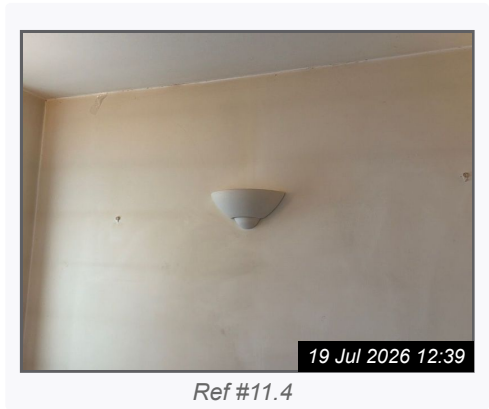
| 11.4 | Lights | 6x Wall mounted fixtures | 1x Not working | |

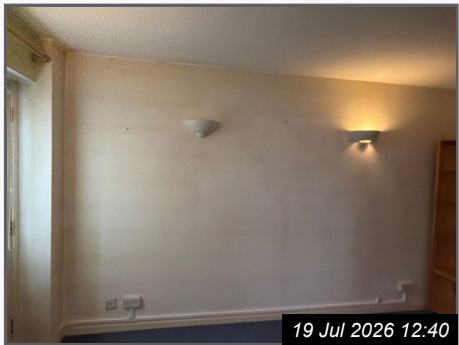
Ref #11.5

| 11.5 | Walls | Cream painted | 6x Picture hooks to high level<br>Notable shading, discolouration, some scuffs, rubs and cracking scattered nearly throughout - Fair wear and tear<br>Needs Maintenance - Tenant | |

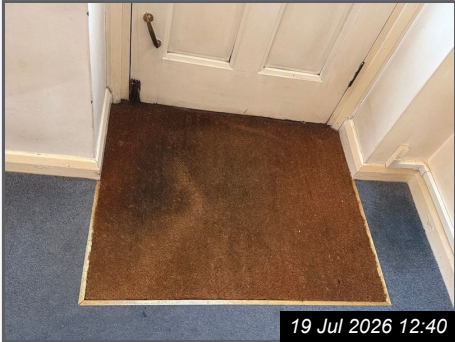
Ref #11.8

| 11.8 | Floor | Blue fitted carpet | Shaded with some discolouration and faint stains - Fair wear and tear | |

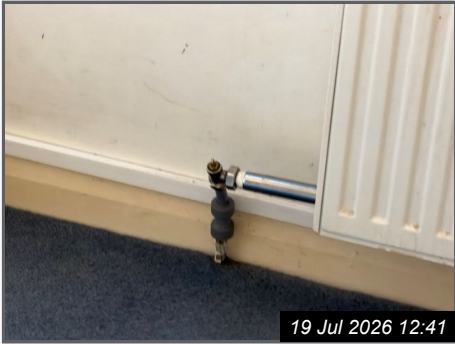
| 11.9 | Heating | White metal radiator with controls | Left end cap not seen<br>Needs Replacing - Tenant | |

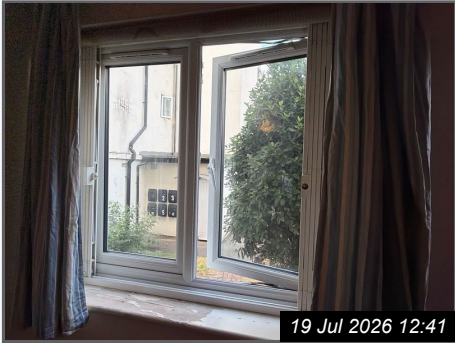
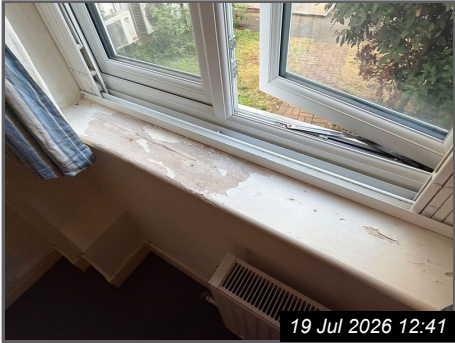
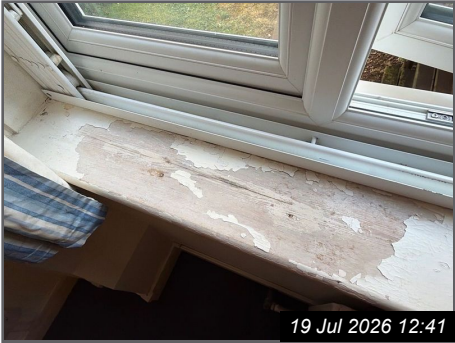
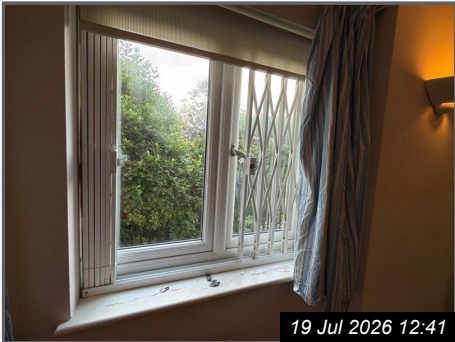
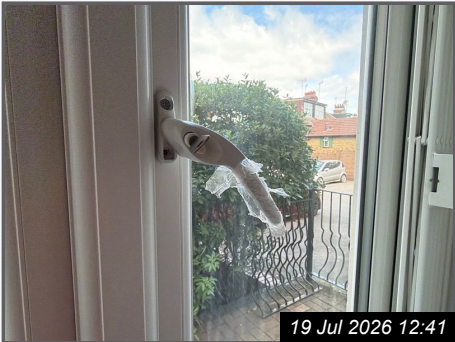
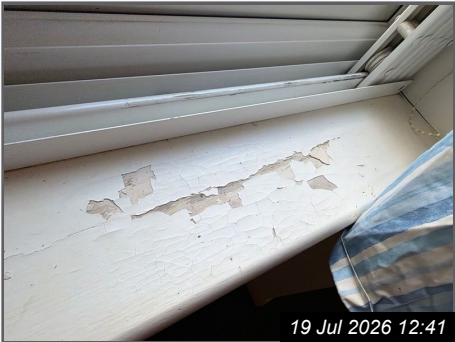
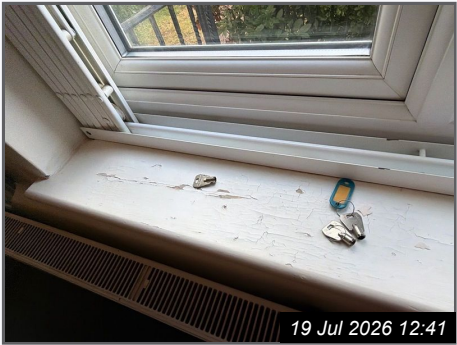
| 11.10 | Windows and Frames | 2x White UPVC<br>White metal handles with lock<br>Off-white painted sills<br>3x Keys | Heavy paint flaking to sills, mostly to left hand side sill<br>Plastic film to handle<br><div>Needs Maintenance - Investigate</div> | |

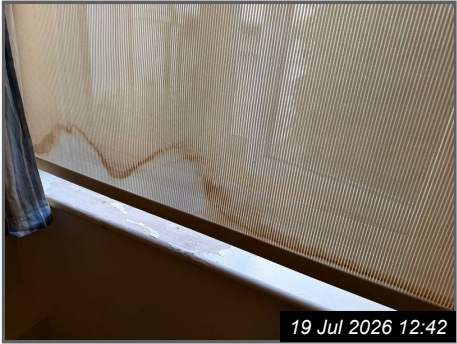
| <div><div><div>Ref #11.11</div></div><div><div>Ref #11.11</div></div></div> | | | | |

| 11.11 | Curtains and Blinds | Notable stains to blind low level<br>Cord broken | Needs Maintenance - Investigate | |

| Needs Maintenance | | |
|---|---|---|
| <u>11.11</u> RECEPTION » Curtains and Blinds | Investigate | Notable stains to blind low level<br>Cord broken |

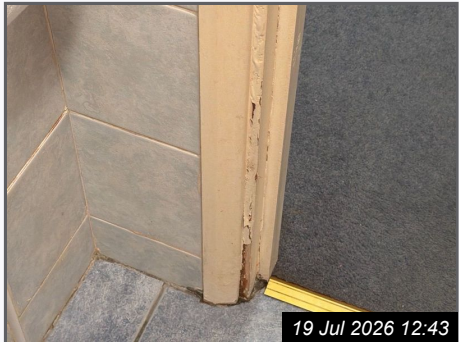
Ref #12.1

| Ref | Name | Description | Condition | Additional Comments |
|---|---|---|---|---|
| 12.1 | Door and Frame | Cream painted wooden | Chipping and cracking to frame - Fair wear and tear | |

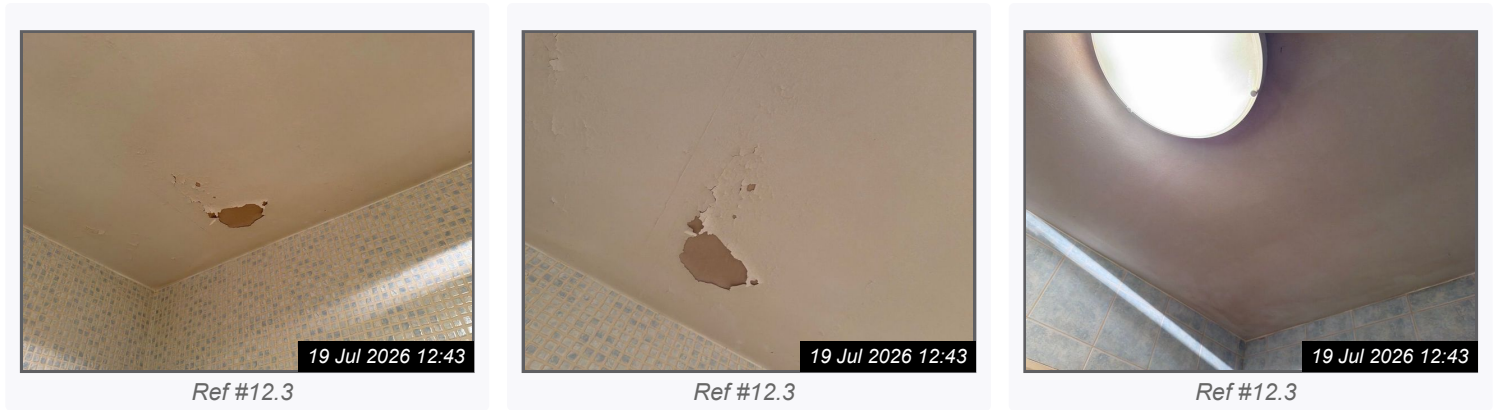
| 12.3 | Ceiling | White painted | Heavy paint flaking to bath area<br>Shading - Fair wear and tear<br>Needs Maintenance - Investigate | |

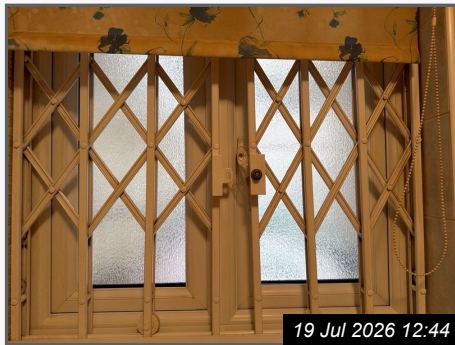
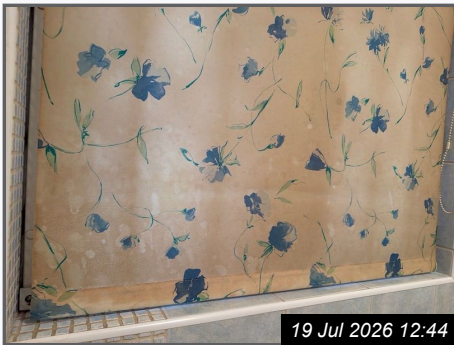
| 12.9 | Curtains and Blinds | White metal security grilles<br>Beige and blue patterned roller blind, pull cord | Discoloured / stained - Fair wear and tear | |

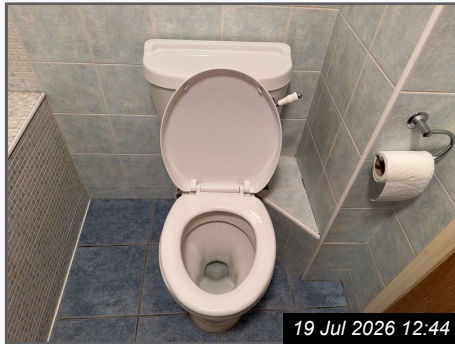
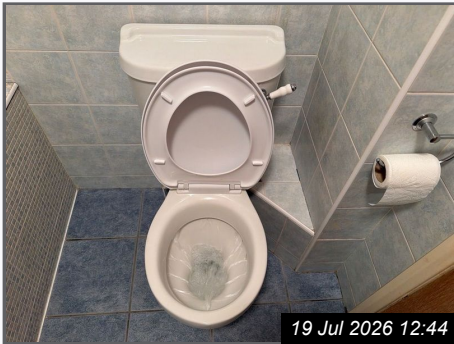
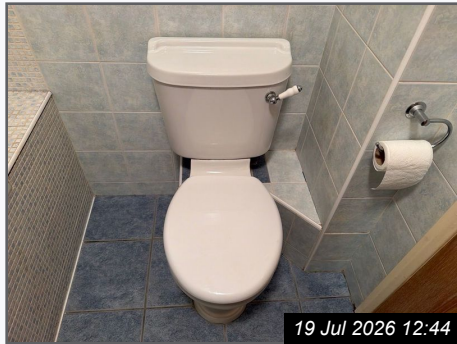
| 12.10 | Toilet | White ceramic, white acrylic seat and lid, chrome flush | Tested and working<br>Clean |

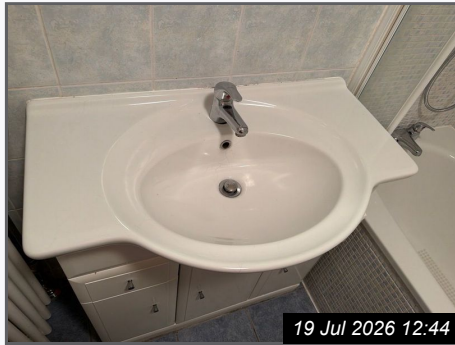
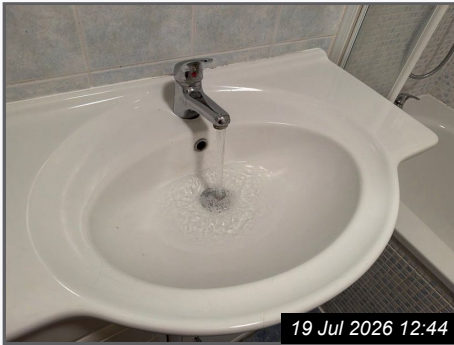
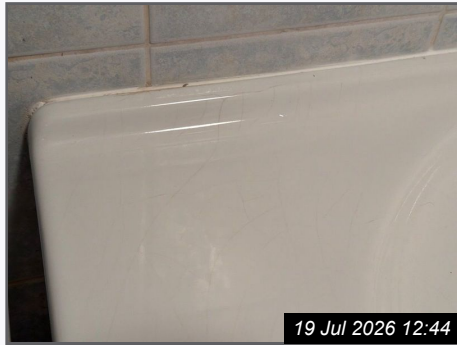
| 12.11 | Washbasin | White ceramic bowl, chrome waste, plug, overflow, mixer tap | Tested and working<br>Light and moderate faint dark cracks to bowl - Fair wear and tear<br>Minor mould to sealant<br>Clean<br><div>Needs Cleaning - Tenant</div> |

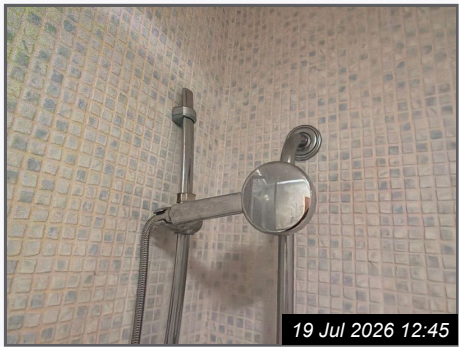
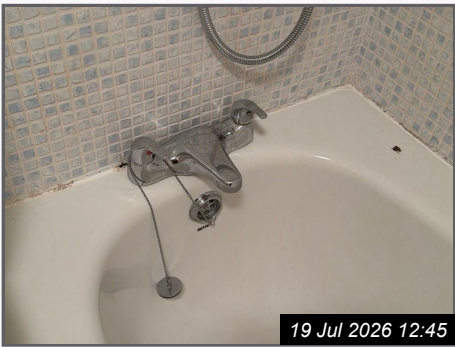
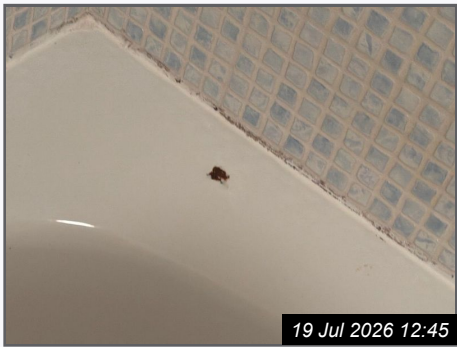
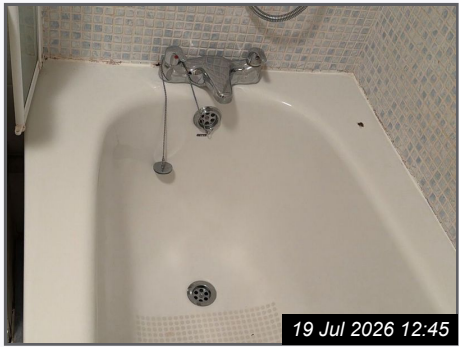
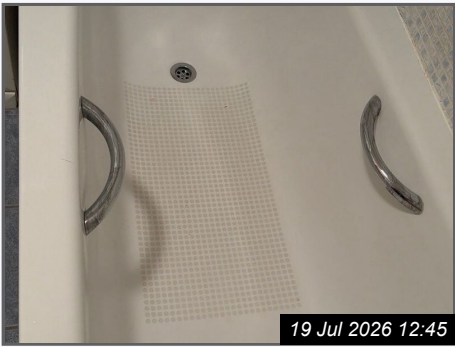
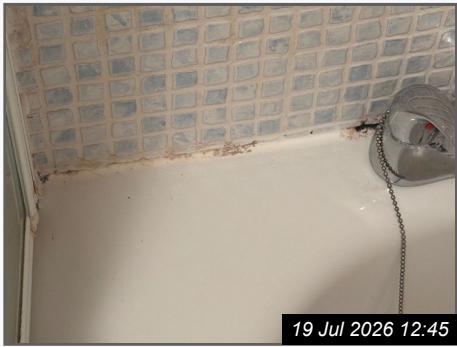
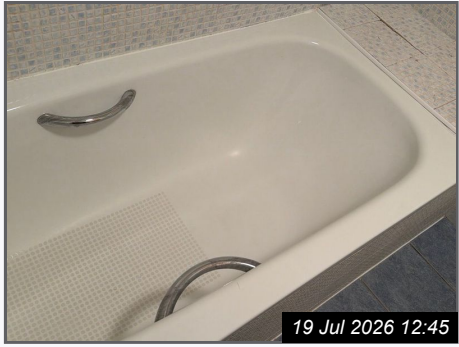
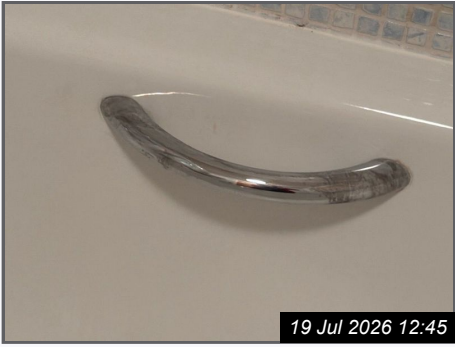
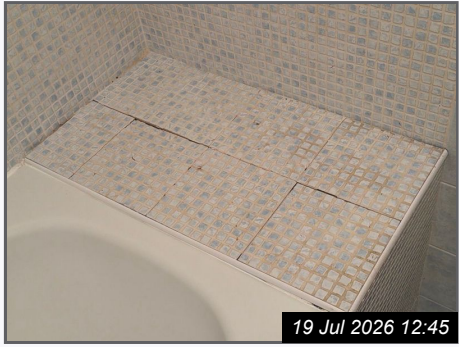
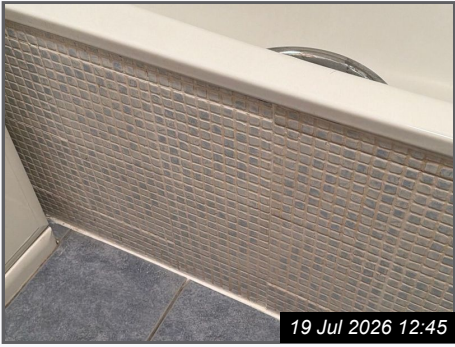
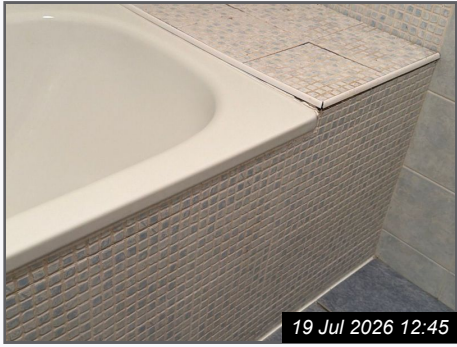
Ref #12.12

| 12.12 | Shower / Bath Unit | Chrome: shower head, riser, hose, holder<br>Glass screen<br>White ceramic tub, chrome waste, plug, overflow, mixer tap, side panel | Not tested<br>Minor brown stains to sealant and dark discolouration to tub<br>Tarnishing to grab handles<br>Minor to slightly more moderate chip to tub right of mixer tap<br>Light scuff to tub<br>Light wear to tiled worktop - Fair wear and tear<br>Shower screen part detached, seen left to floor to Hallway | Needs Maintenance - Investigate |

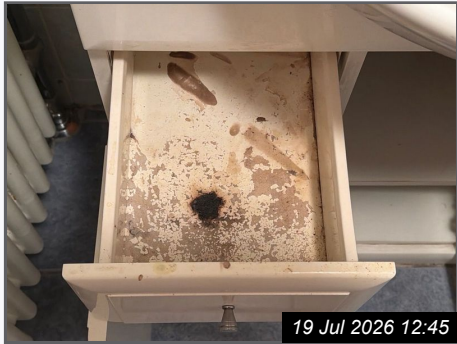
Ref #12.13

| 12.13 | Vanity Unit | Off-white laminate<br>Metal pulls | Heavy stains and burn marks<br>Needs Maintenance - Tenant | |

| Needs Maintenance | | |
|---|---|---|
| <u>12.13</u> BATHROOM » Vanity Unit | Tenant | Heavy stains and burn marks |
